STREAM CROSSING INVENTORY PROJECT - '97

December 08, 1997

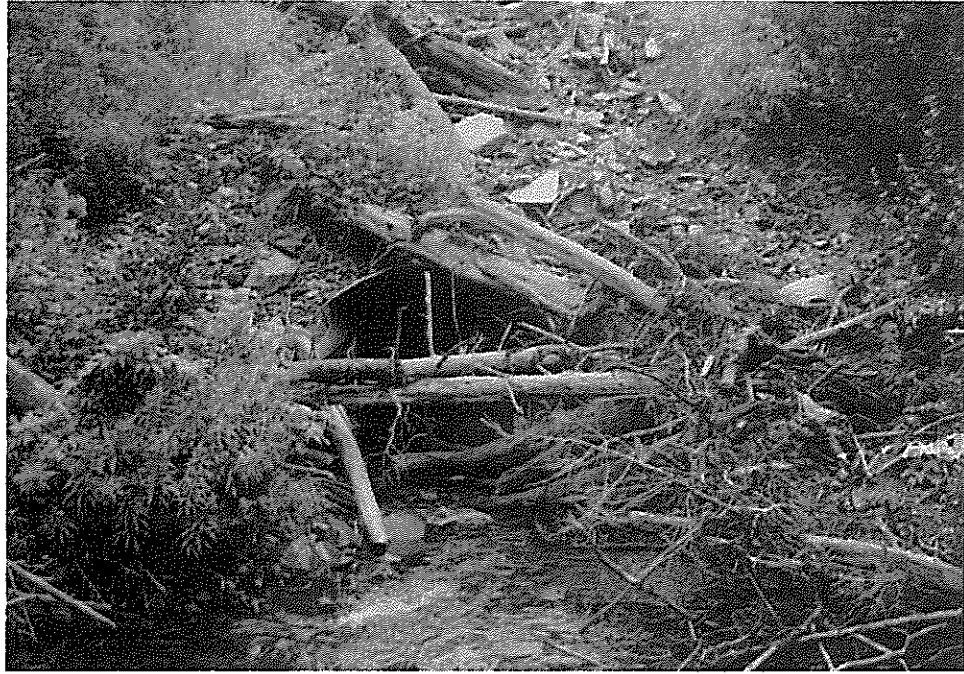
Codroy Area

Please note that the following stream crossing photographs are documented due to the severe nature of the impairment, not all crossings were in this condition, the majority had only minor obstructions. Approximately 40% of the stream crossing structures surveyed are in need of immediate maintenance or upgrading.
